PRODUCED WATER PIPELINE RELEASE INTO A NATIVE PASTURE SETTING (20182985)

Location: 12-01-020-12 W4M – Southern Alberta

Industry: Upstream Oil and Gas

Product Released: Produced Water

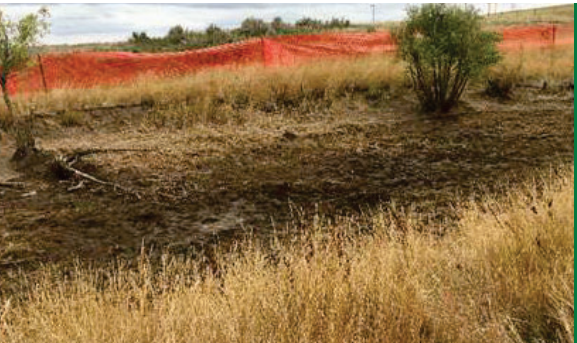
View of vegetation stress to the native pasture observed within the spill path.

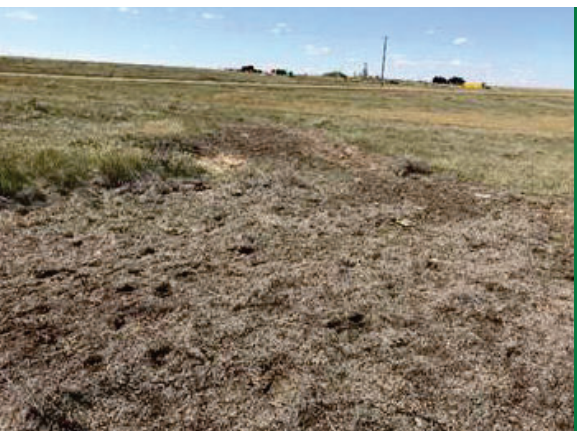
Vegetation stress was monitored throughout the spill path. This bare area was observed during vegetation monitoring conducted in 2019.

Ridgeline conducted a vegetation assessment of the release area on September 5, 2019. A bare area was observed extending northwest from the surficial point of release for approximately 150 m. An area of sparse vegetation was observed extending from the bare area north towards the culvert for approximately 80 m.

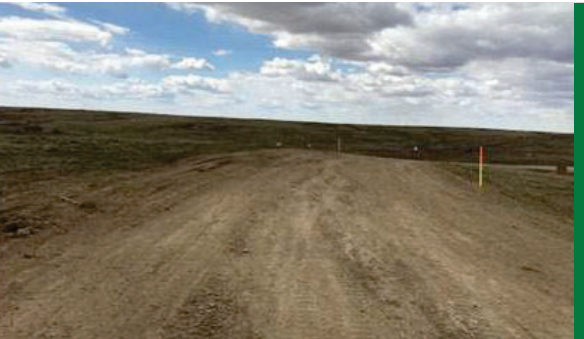
Once the impacted soil was successfully excavated, the impacted area was backfilled and recontoured with a soil with similar physical and chemical properties to those found within the region.

Following the completion of backfilling, the former excavation was re-contoured to the surrounding topography and seeded with an approved EID reclamation seed mix.

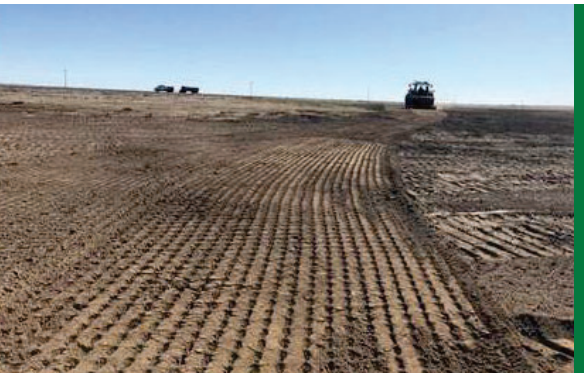
After all the rig mats and temporary roads were dismantled, the impacted areas were harrowed and seeded with an approved seed mix.
