# OIL EMULSION PIPELINE RELEASE INTO FLOWING RIVERINE ECOSYSTEM

## Incident Details

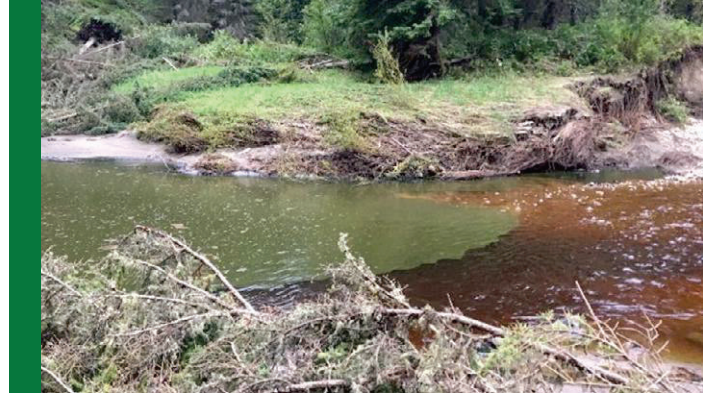
Oil emulsion impacts present in creek downstream of the Point of Entry.

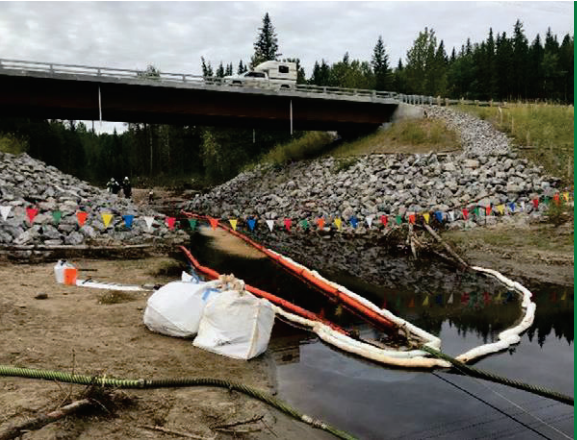
An accessible containment site located down gradient of the point of release.

Initial containment was achieved on August 15, 2019 through river boom deployment downstream of the plume leading edge in the creek. Additional locations for containment boom deployment were selected throughout the emergency response program to maximize the effectiveness of the containment and recovery operations. In total, approximately 1,200 m of boom were deployed in the creek. The boom sets were inspected daily and replaced as needed throughout the duration of the emergency response program.

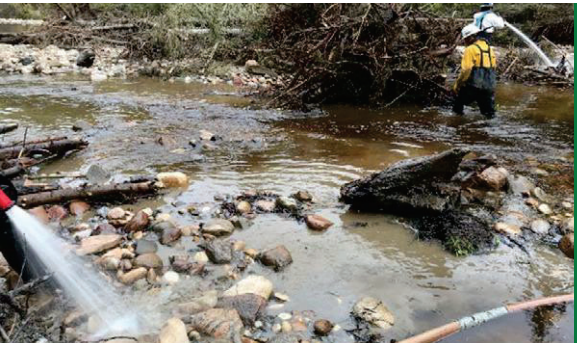
Members of the SCAT crew completing the prescribed cleanup treatment on a gravel and cobble shoreline.

The modified SCAT program was used to determine the treatment technique required for each shoreline classification and to monitor the effectiveness of the recovery and remediation activities. Within the effected section of the creek, four different types of shoreline were identified – cobble, sand, vegetated bank and woody debris. The treatment for cobble was to scrub with brooms to loosen the oil then to wash using 2-inch trash pumps and low-pressure water. The treatment for sand was to rake the heavily stained areas to loosen the oil then to wash using 2-inch trash pumps and low-pressure water. The treatment for vegetated banks was to remove the impacted vegetation with hand tools and place in cube sacks to be transported from the water course via helicopter prior to being disposed of at an approved waste management facility. The treatment for woody debris included cutting the large pieces into manageable sizes and removing from the creek banks. All impacted woody debris was staged in an approved location to be burned during the subsequent winter.

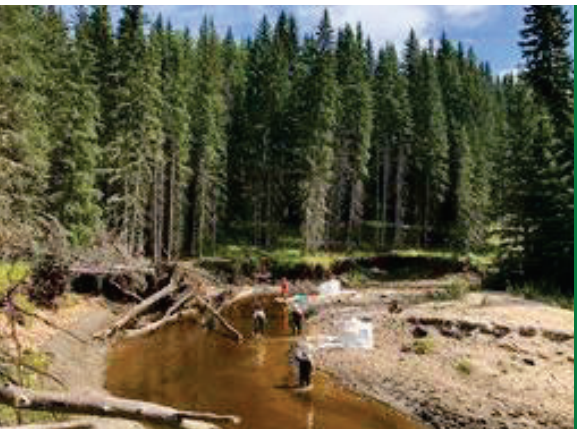
Throughout the duration of the recovery and SCAT programs the turbidity and contaminant levels within the surface water and sediment were continuously monitored.

Throughout the duration of the environmental spill response activities, fixed sampling and monitoring locations were established throughout the watercourse to evaluate the effectiveness of the remediation and recovery activities. Thirteen surface water and four sediment sampling locations were established within the creek, one sampling location was established at the point of confluence with the North Saskatchewan River, and one was established in the North Saskatchewan River downstream of the point of confluence. During high-risk activities, turbidity monitoring was conducted and surface water samples were collected and submitted for laboratory analytical on a daily basis.

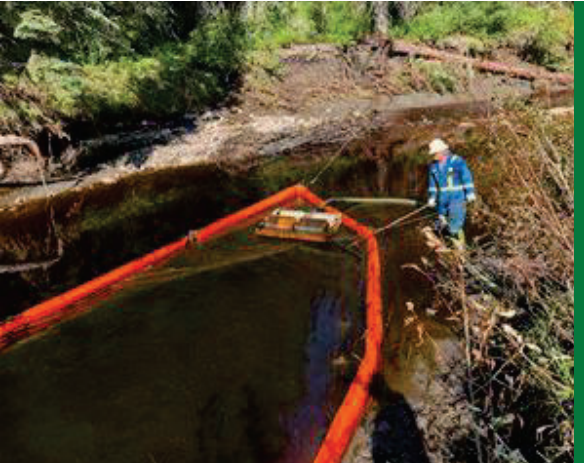
Oil containment and recovery operations being completed within the creek.

Free phase petroleum hydrocarbon was recovered from the creek by skimmers staged at each boom set. Vacuum trucks were used for recovery in locations where truck access was feasible. In the remote sections of the creek, product was recovered via portable drum vac and was temporarily stored in barrels, then transported from the creek via helicopter. All recovered fluids were disposed of at an approved waste management facility.

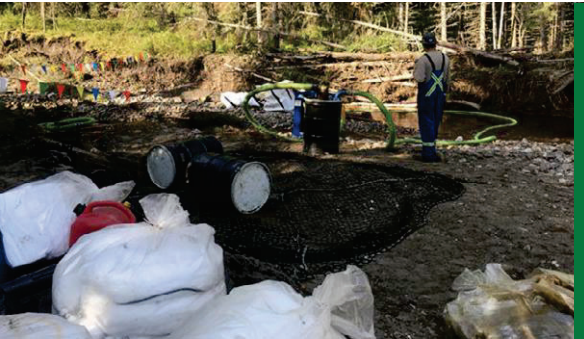
Portable drum vacuum units were used to recover oil in remote locations throughout the release area.

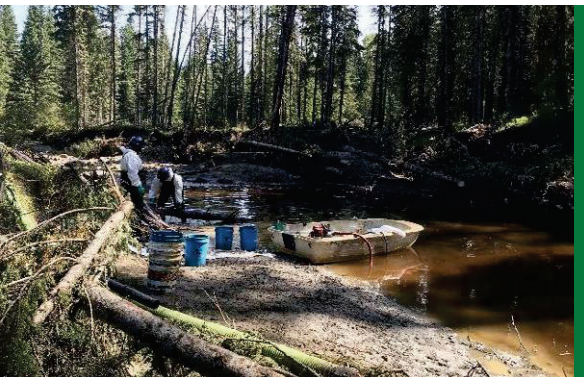
The SCAT crew utilizing portable low flow pumps to wash the impacts from the fallen woody debris within the release area.

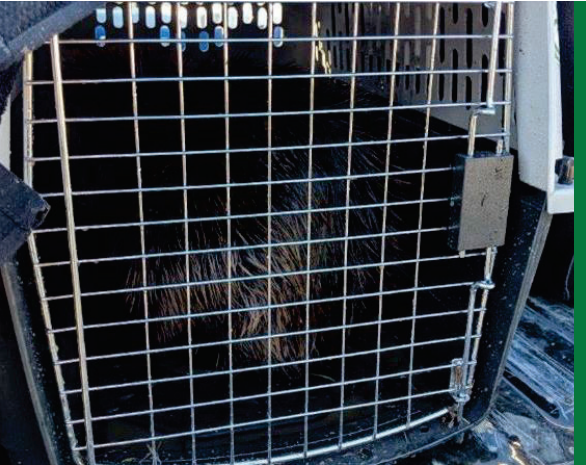
Transporting a captured beaver to a wildlife rehabilitation facility.

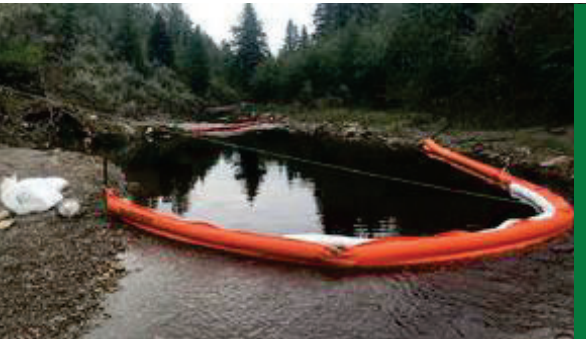
River boom was staged throughout the creek to prevent the oil from migrating downstream.

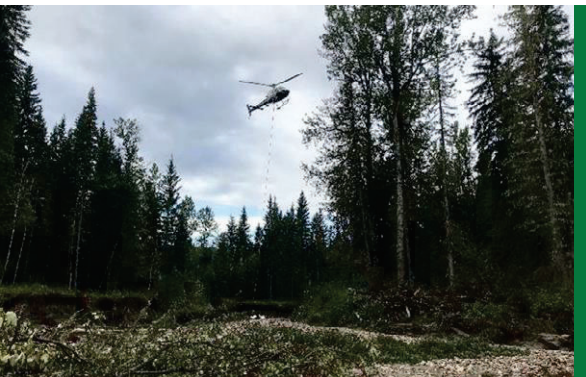
Using a helicopter to longline impacted material from the creek to the staging area in preparation for disposal.

Ridgeline encountered numerous challenges throughout this project. As most of the creek was only accessible on foot, the majority of the recovery and remediation tactics deployed were very labour intensive and the equipment was transported via helicopter.
