OIL EMULSION PIPELINE RELEASE INTO A WETLAND COMPLEX & FRESHWATER ECOSYSTEM

Location: Northern Alberta

Product Released: Emulsion (50% produced water, 50% crude oil)

Volume Released: 250 m³ (250,000 litres)

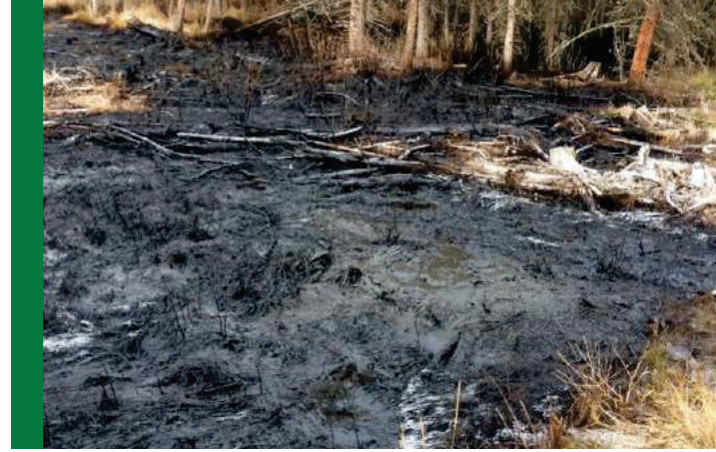
Surficial petroleum hydrocarbon impacts observed during the initial reconnaissance throughout the wetland complex.

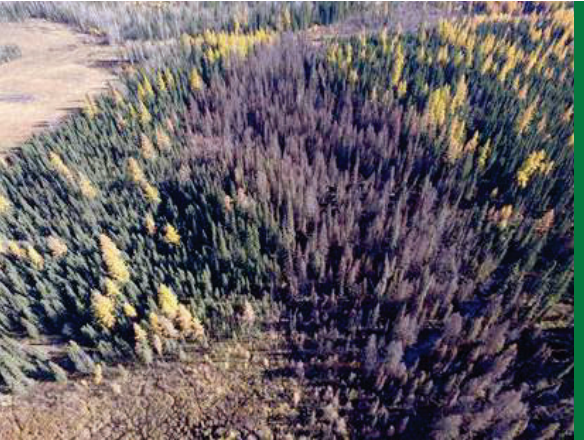
UAV photograph of the immediate affected area indicating the stressed vegetation observed upon initial assessment.

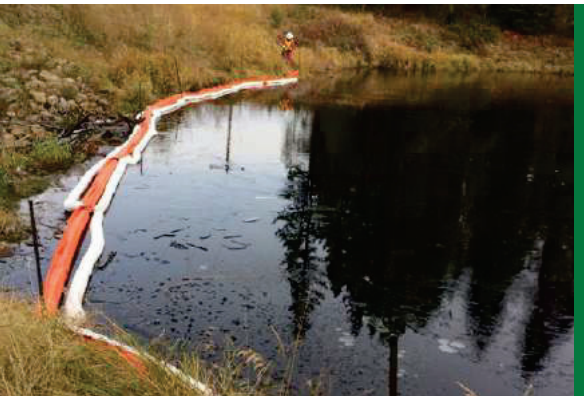
Containment boom was immediately deployed within the unnamed tributary of the losegun River at various control points located downstream from the point of entry.

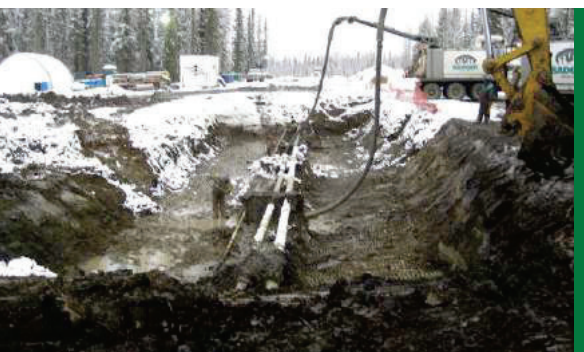
During the investigation and repair, the source impacts from the pipeline breakpoint area were excavated and disposed of at an approved waste management facility.

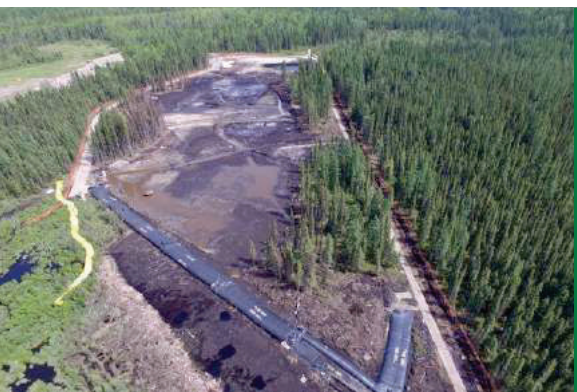
Access roads with swamp matting were constructed to access the impacted areas and point of entry from the wetland complex into the unnamed tributary. A series of terrestrial barriers were keyed into the subsoil to provide primary containment.

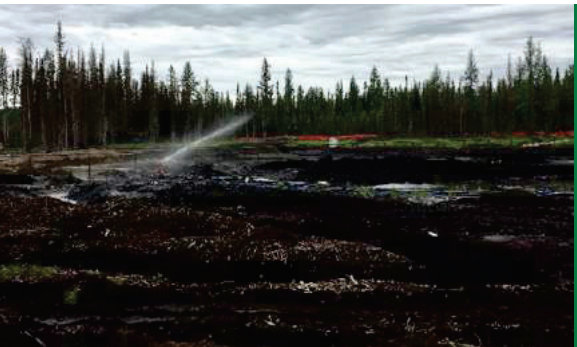
The salinity impacts in the soil were remediated by utilizing an active freshwater flushing, recovery, treatment, and disposal system throughout the 2017, 2018, and 2019 remediation seasons.
